# **The role of vegetation in characterising landscape function on rehabilitating gold tailings**

Dissertation submitted in fulfilment of the requirements for the  
degree Master of Science at the Potchefstroom campus of the  
North-West University

November 2008

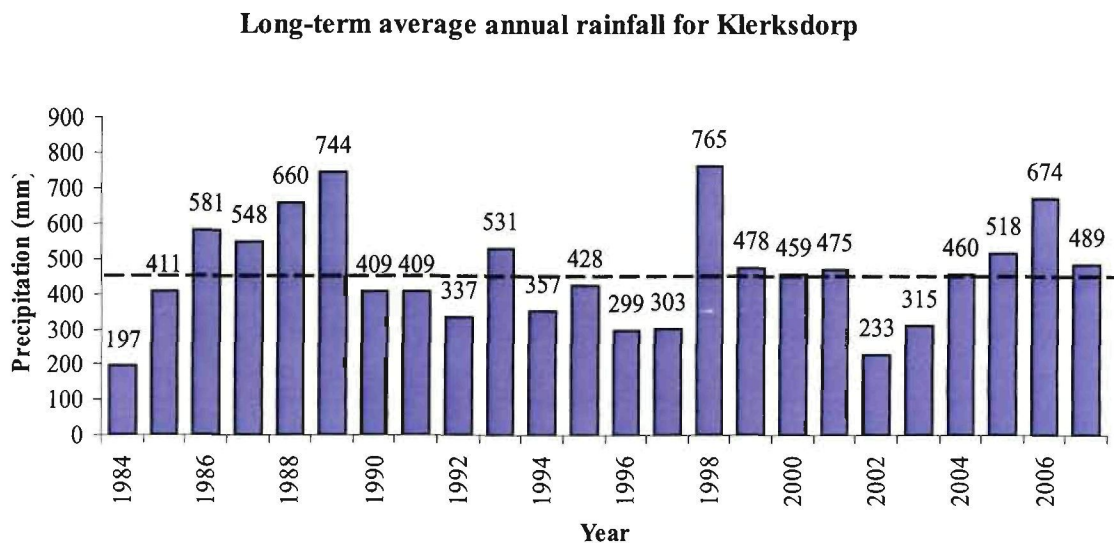
**Figure 3.3.** Annual precipitation at Klerksdorp weather station from 1984-2007. Klerksdorp was the closest weather station, situated 14 km to the west of the study site. The dashed line indicates the average annual rainfall of 468mm from 1984-2007.

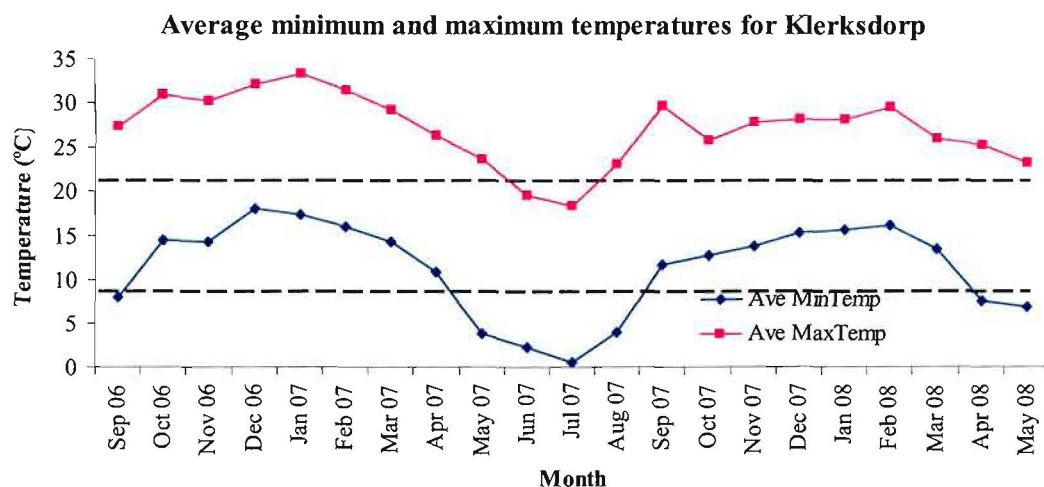
**Figure 3.4.** The average monthly minimum and maximum temperatures for Klerksdorp weather station during the 2006/07 and 2007/08 seasons. Klerksdorp was the closest weather station, situated 14 km to the west of the study site. The dashed lines indicate the average long-term monthly minimum and maximum.

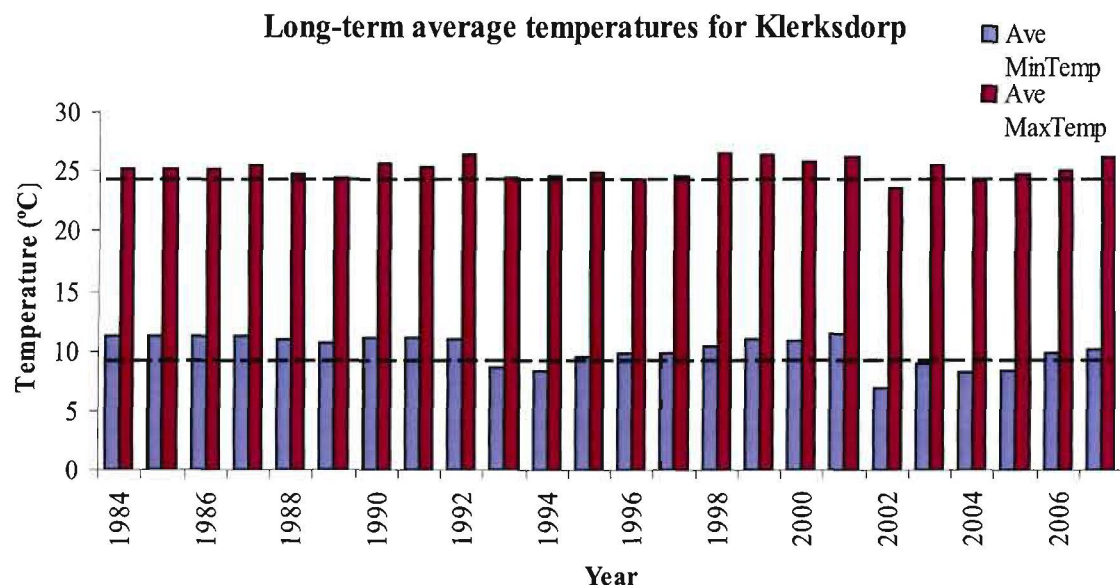
**Figure 3.5.** The average annual minimum and maximum temperatures for Klerksdorp weather station from 1984-2007. Klerksdorp was the closest weather station, situated 14 km to the west of the study site. The dashed lines indicate the average annual minimum and maximum from 1984 to 2007.

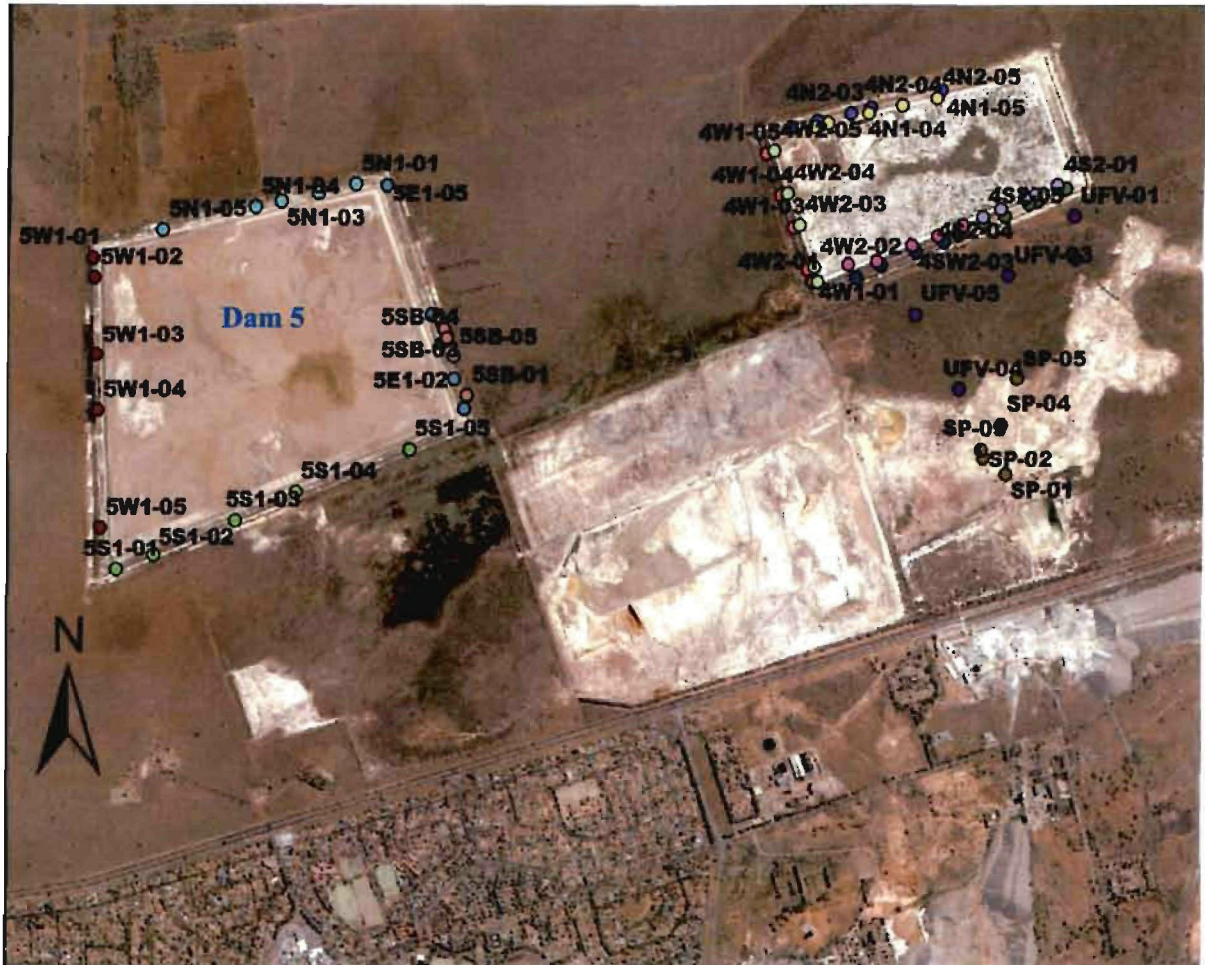
Chemwes site and transect localities

Figure 4.1. Quickbird™ aerial photograph of the Chemwes Tailings Complex, showing the relative location of sample sites. Site names and abbreviations re explained in Appendix A.

The focal areas within the Chemwes tailings complex were the no 4 and no 5 tailings dams, and the spillage area to the east of tailings dam no 2 (Figure 4.1). For selection of study sites, the first level of stratification was aspect. Due to the southerly latitude, the inclination of the sun, abiotic characteristics such as temperature insulation, photoperiod and moisture relations were expected to vary markedly between aspects (Bennie *et al.*, 2006; Kawule, 2007). These variations then had direct influences on the vegetation associated with these different aspects (Bennie *et al.*, 2006). At the coarser scale (i.e. larger areas) there are differences in plant cover and often species composition, whilst the finer scale (i.e. more detailed) differences may be more subtle, altering phenological responses (Barbour *et al.*, 1998). The second level of stratification was based on the different age-units on the different aspects. The length of time that a unit has had to be subject to resource competition, soil processes and environmental factors post-rehabilitation will have an effect on the basic soil characteristics and vegetation responses. If plant succession does take place on these rehabilitating tailings, then we can expect to see different substrate-associated plant communities with some degree of likeness in similarly aged sites on corresponding aspects (but only if substrate chemistry is similar). This likeness can be expressed in terms of species structure and the functional role of the vegetation community. The third level of unit stratification was based on the site management history, which described the anthropological influences to the site. This involved a further level of stratifying the already partitioned units into smaller subdivisions based on whether they were rehabilitated in different ways or at different times. Factors that were considered here were irrigation, the use of fertilisers, original tailings material (some of the tailings materials had pyrite extracted), the addition of Mycorrhizae, areas that were reworked or reseeded, and soil ameliorants (as per Table 4.1).

In summary, there were only two sites that consistently fell below threshold values for all three LFA indices (Stability, Infiltration and Nutrient cycling) and across both years (Table 5.10). These were the spillage site (SP) and 4SE1 (for site localities please see Figure 4.1). These were the two least functional sites and presented some level of concern, as their landscape function was declining over time. However, as the spillage site was situated on flat slope and the majority of surface material consisted of actual soil, it was of less concern for Stability if the current levels of spontaneous vegetation colonisation could be maintained. Strategic positioning of brush packs would certainly be very beneficial to this site by collecting mobile seed and topsoil and creating a safe microclimatic zone for germination., These strategies are further explained in section 6.5.

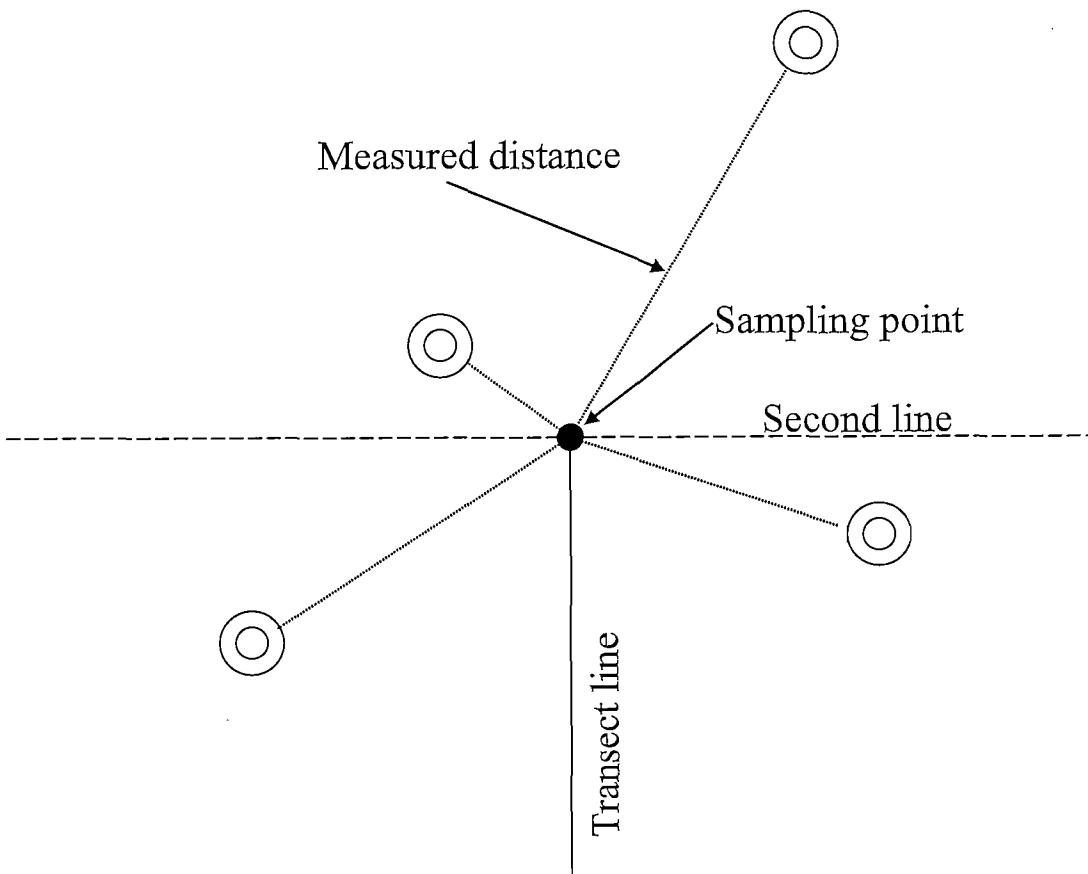
**Figure 4.3.** A schematic representation of the Point-Centred Quarter method (From Tongway and Hindley, 2004).

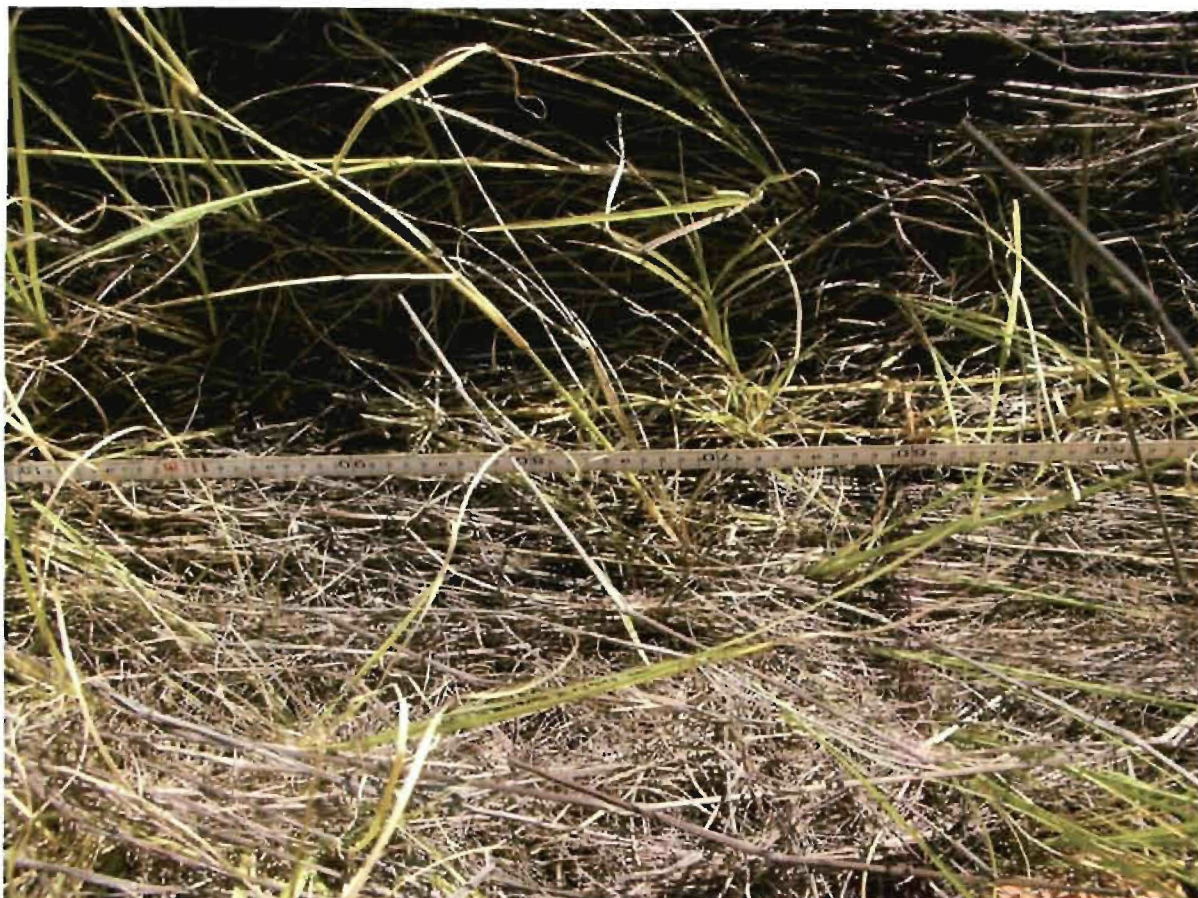
**Figure 4.8.** Example of a Grassy Litter patch on the line transect.

GLP's (Figure 4.8) were also very prevalent across most landscapes, especially where moribund perennial grasses were shedding dead leaves. This patch type was characterised by a mixture of above-surface litter, some subsurface litter in various degrees of decomposition, and live perennial grasses in between. Care was taken to establish that the litter actually came into contact with the soil and plants, indicating that all were part of a single unit that effectively controlled the cycling and flow of mobile resources. Litter cover varied in extent, but covered at least 90% of the soil surface and with no gaps large enough for runoff to cause litter or sediment movement. This patch type had large amounts of litter cover that were in contact with the soil, which (1) facilitated improved moisture absorption and infiltration; (2) reduced the erosive percussive impacts of raindrops; (3) added organic matter to the carbon-poor soil (which promotes soil aggregation and microbiological nutrient cycling); (4) created a habitat for microorganisms; and (5) created a "physical sieve" that collected mobile resources such as plant litter and seeds. All of these factors resulted in a highly functional patch type, albeit one that was not found in any of the least functional landscapes on the continuum. The live vegetation too, added greatly to the functionality of this patch type by recycling nutrient resources and maintaining production for further litter

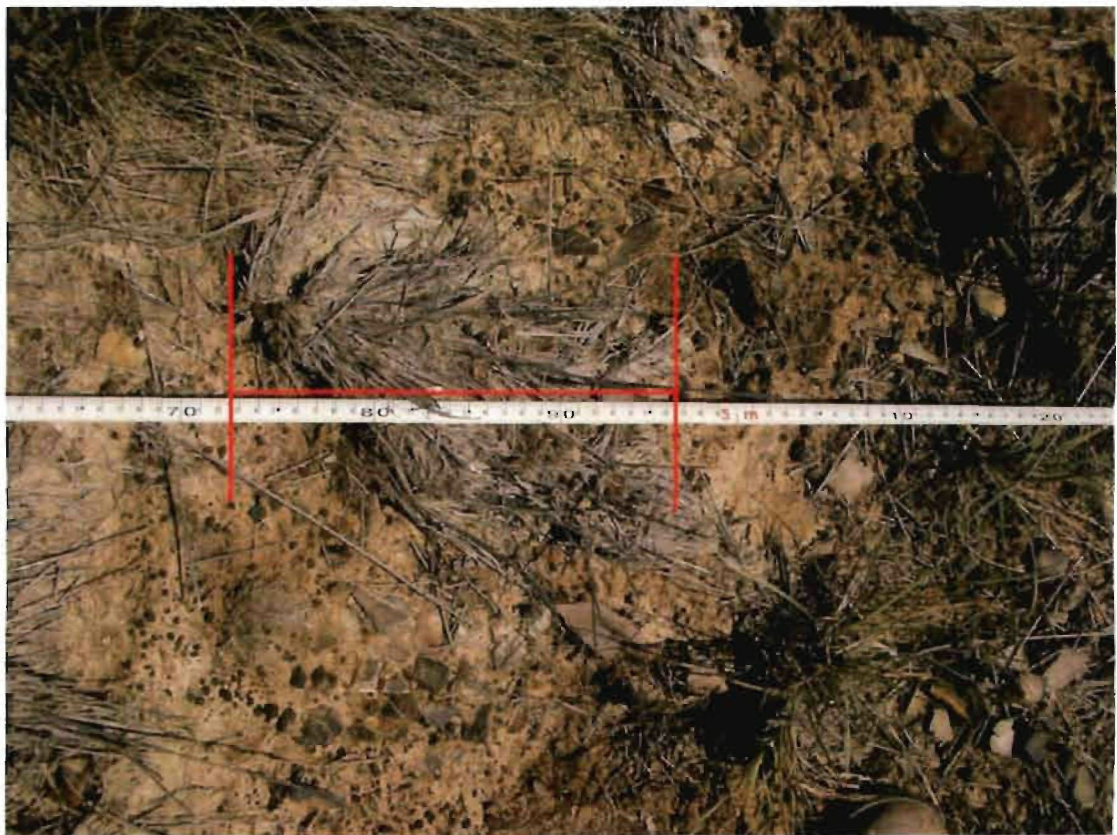
**Figure 4.9.** Example of a Litter patch on the line transect with dimensions indicating the extent of the patch and separating it from the surrounding interpatch.

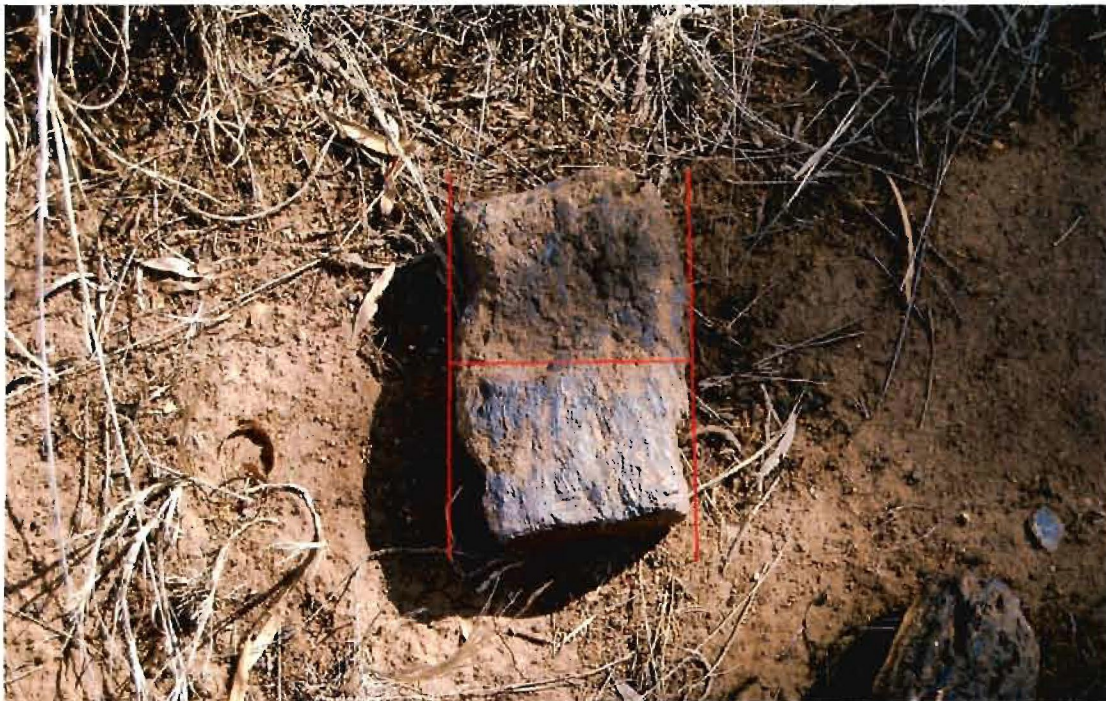
**Figure 4.11.** Example of a Rock patch, not on the line transect, with dimensions indicating the extent of the patch and separating it from the surrounding interpatch.

RP's (Figure 4.11) were never encountered on the TSF slopes, but were frequent on the starter walls, and in the spillage area and undisturbed grasslands. Overall, it was the eighth most frequently encountered patch type. RP's consisted of rocks, unbroken by soil or vegetation. Although RP's added somewhat to the stability of landscapes, they had no direct effects here on their infiltration or nutrient cycling capacity. A rocky surface can often minimise the formation of physical crusts which slow infiltration. There were, however, potential indirect effects on nutrient cycling such as the provision of shelter for macroinvertebrates that played highly functional roles ("ecosystem engineers", Lavelle *et al.*, 1997; Wright and Jones, 2006) themselves in aeration and contribution to soil structural development.

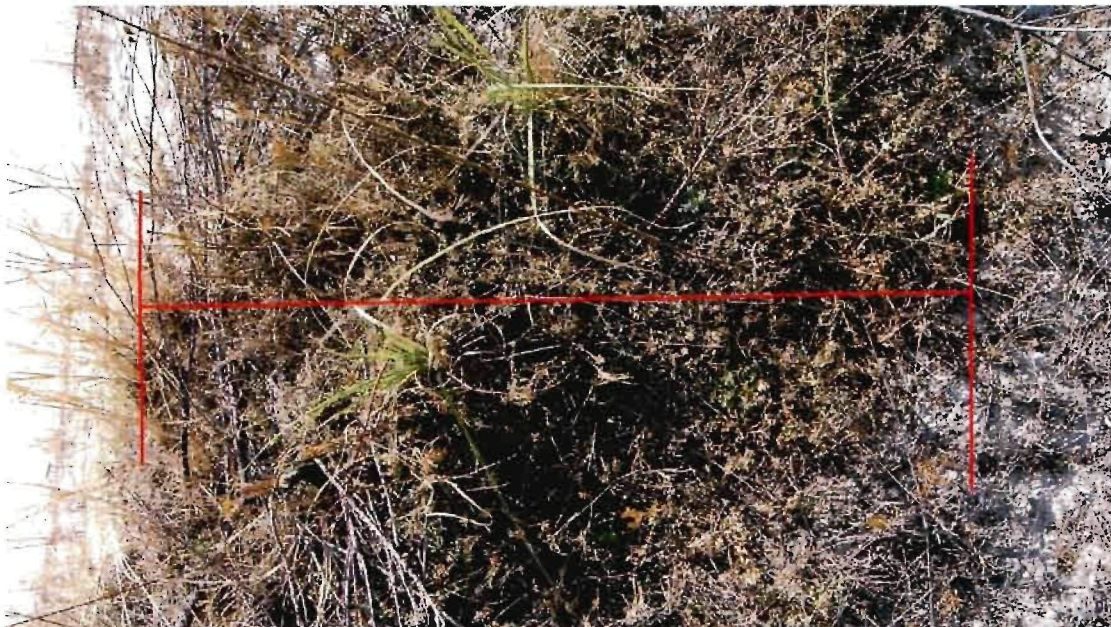
**Figure 4.14.** Example of a Herb patch with dimensions indicating the extent of the patch and separating it from the surrounding interpatch.

HP's (Figure 4.14) were seldom observed on the TSF slopes and were only the ninth most common patches of thirteen types. These consisted of live, often perennial and low-growing/prostrate herbaceous plants that had sufficient structure and foliage at ground level to aid in the accumulation of mobile resources, such as water, soil particles and seeds. Single-stemmed, erect herbaceous plants were omitted from this category as they did not possess sufficient basal cover to contribute to resource retention. Whilst these were moderately functional patch types that contributed to the functional diversity of the landscapes, their occurrence was erratic and their overall importance was low.

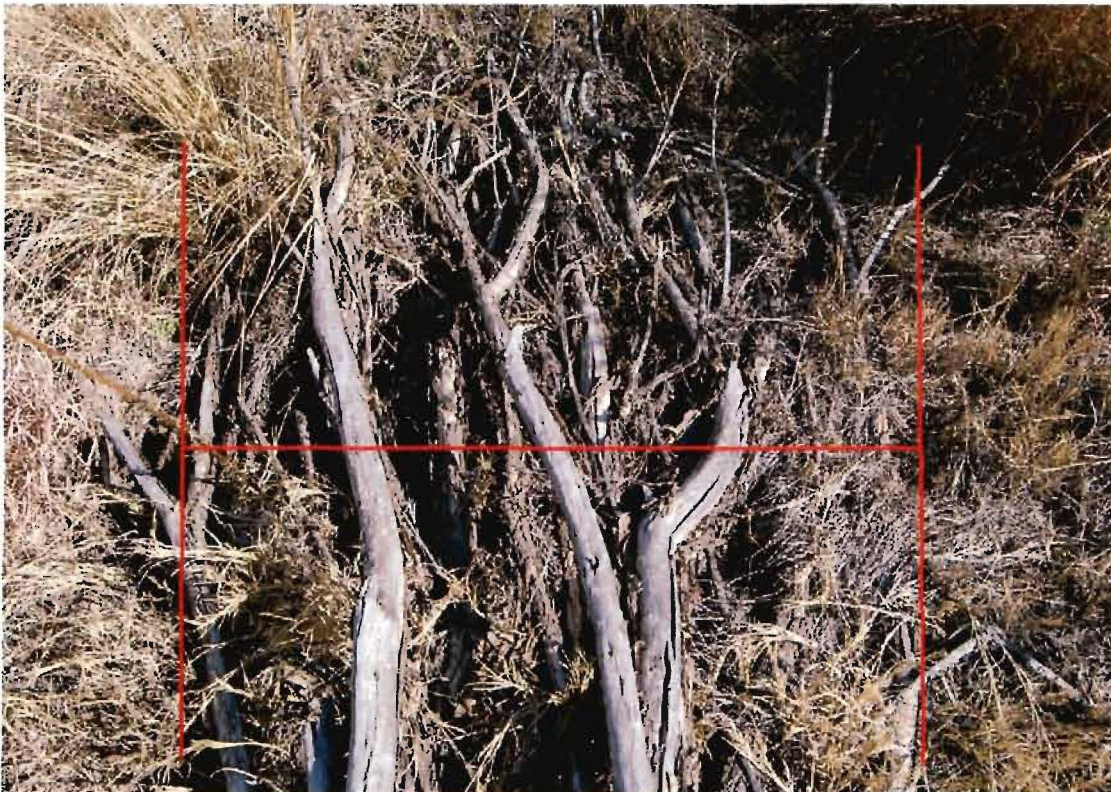
**Figure 4.18.** Example of a Woody Litter patch with dimensions indicating the extent of the patch and separating it from the surrounding Grass patches.

WLP's (Figure 4.18) were limited to a single patch, occurring in only one transect and observed in both survey years. It was an atypical patch type, although readily identifiable. The patch consisted of broken tree trunks and roots, interspersed with accumulated plant litter that were, in all likelihood, disturbed and deposited by vehicular activity. The WLP was highly functional in terms of structure, and the indices of stability, nutrient cycling and infiltration. This was as a result of the enduring nature of the structure, the accumulation of organic material, and the habitat creation for macroinvertebrates.

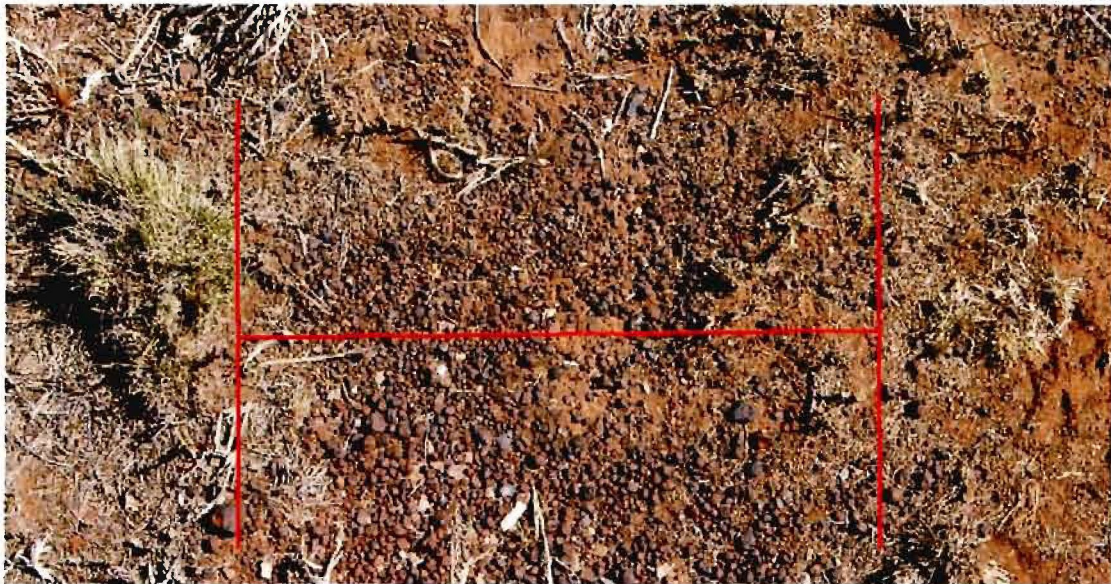
**Figure 4.20.** Example of a Gravel interpatch with dimensions indicating the extent of the patch and separating it from the surrounding patches.

GRI's (Figure 4.20) occurred in only 8% of transects (Table 5.2) and in two sites, the starter wall and the undisturbed grassland. GRI's were characterised by a modicum of gravel-sized stone particles (>2 mm), overlying bare soil. The gravel enhanced the functional attributes of this interpatch type by adding structural dimensions and therefore aiding in topsoil retention. However, resources were still lost from these patches, hence their interpatch classification.

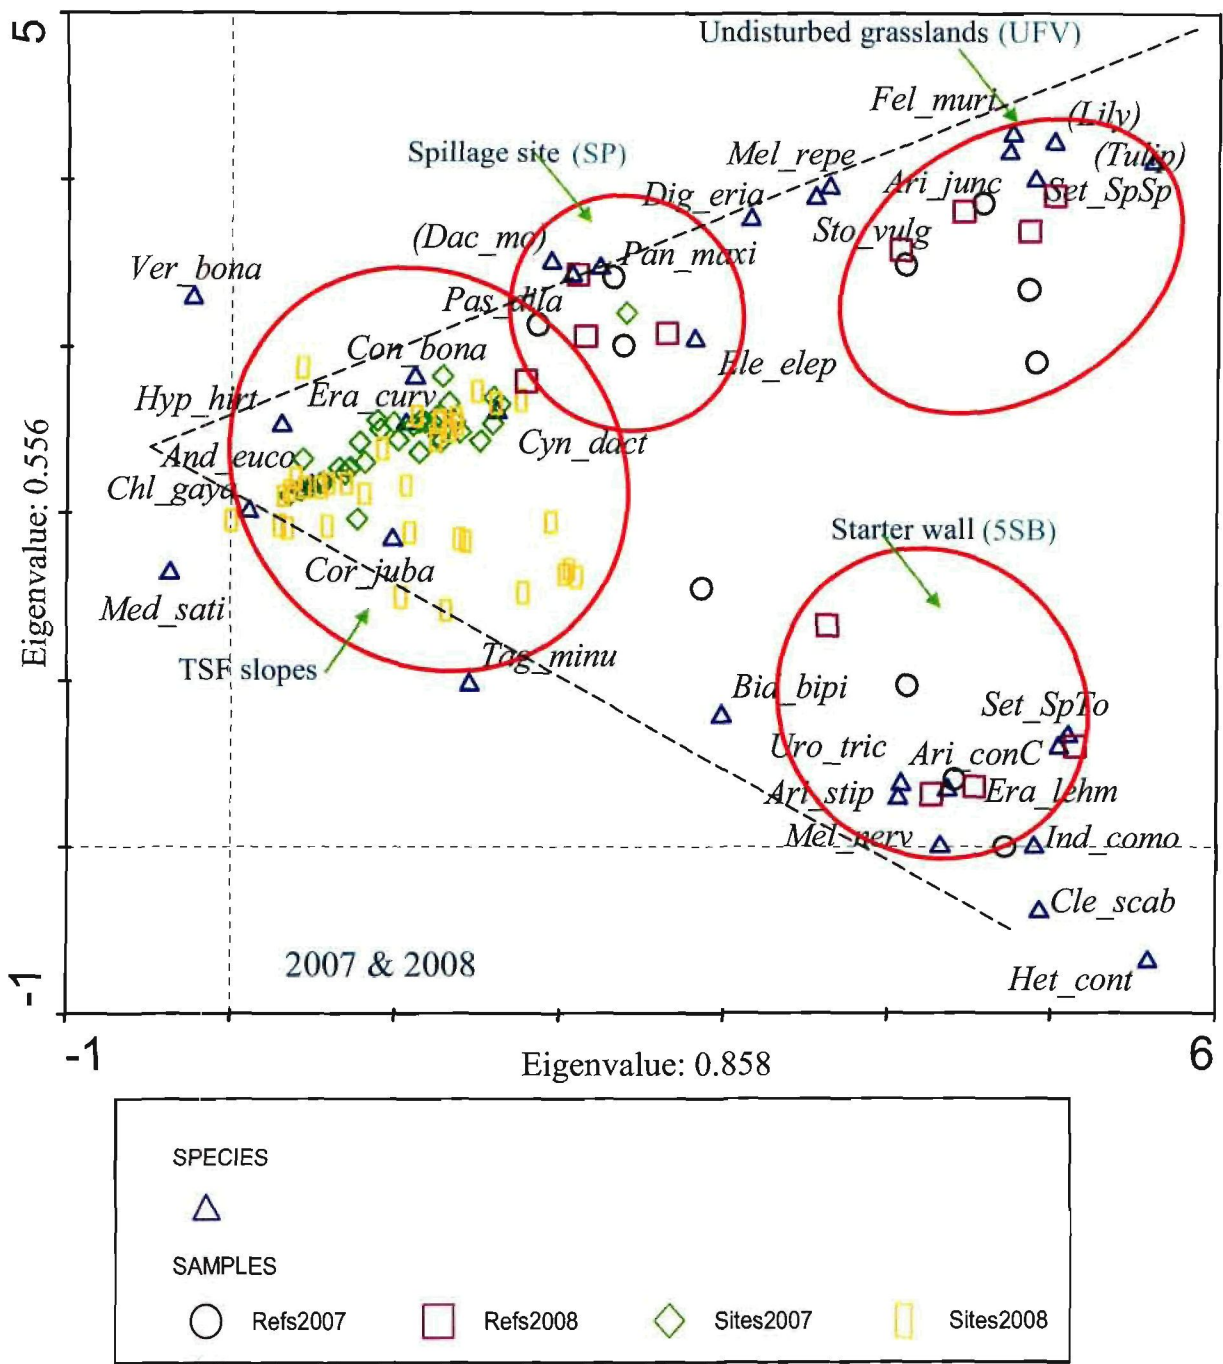
**Figure 5.2.** Detrended Correspondence Analysis (DCA) of the vegetation data for 2007 and 2008 across all sites. The reference sites (indicated as “Refs 2007” and Refs 2008”) are the SP, UFV and 5SB sites, whilst the rest make up the TSF sites (indicated as “Sites” 2007 and 2008). Abbreviations are given in Appendix A and species codes are explained in Appendix C.

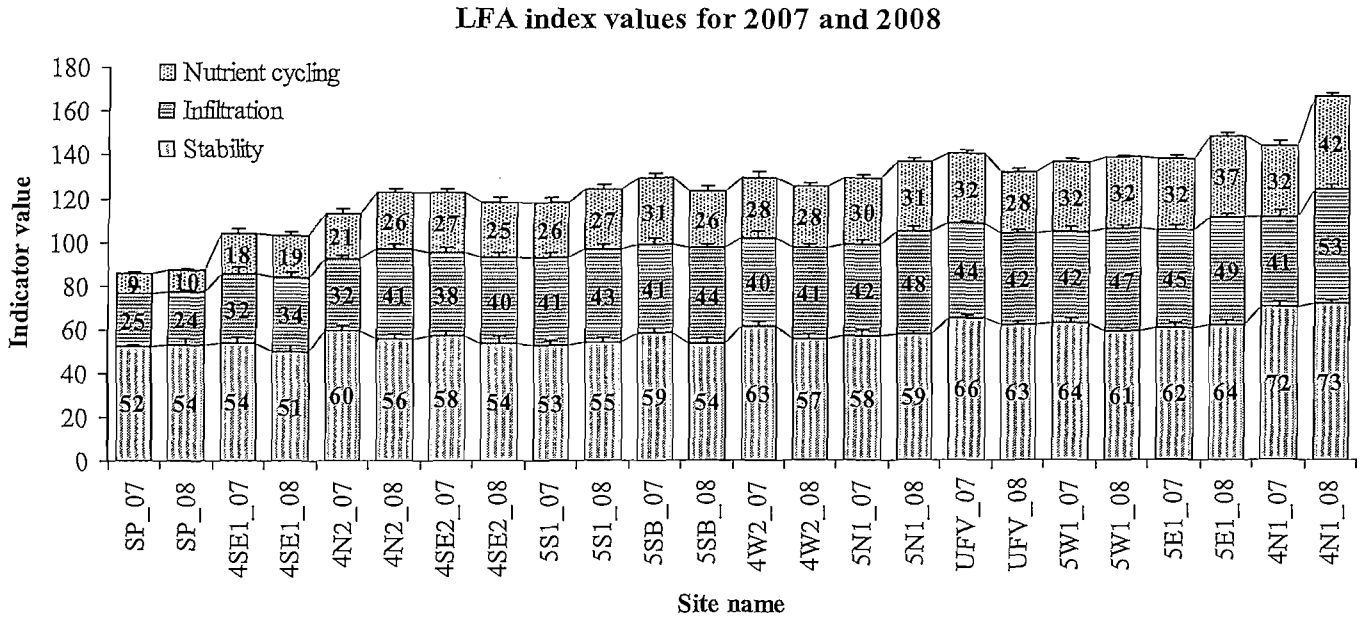
**Figure 5.7.** Average landscape function index scores (individual transect scores in Table 5.3) for each site, presented here as a sigmoidal curve ordered by the ranking of total values for each site. This presents the data on a continuum from least to most functional sites.

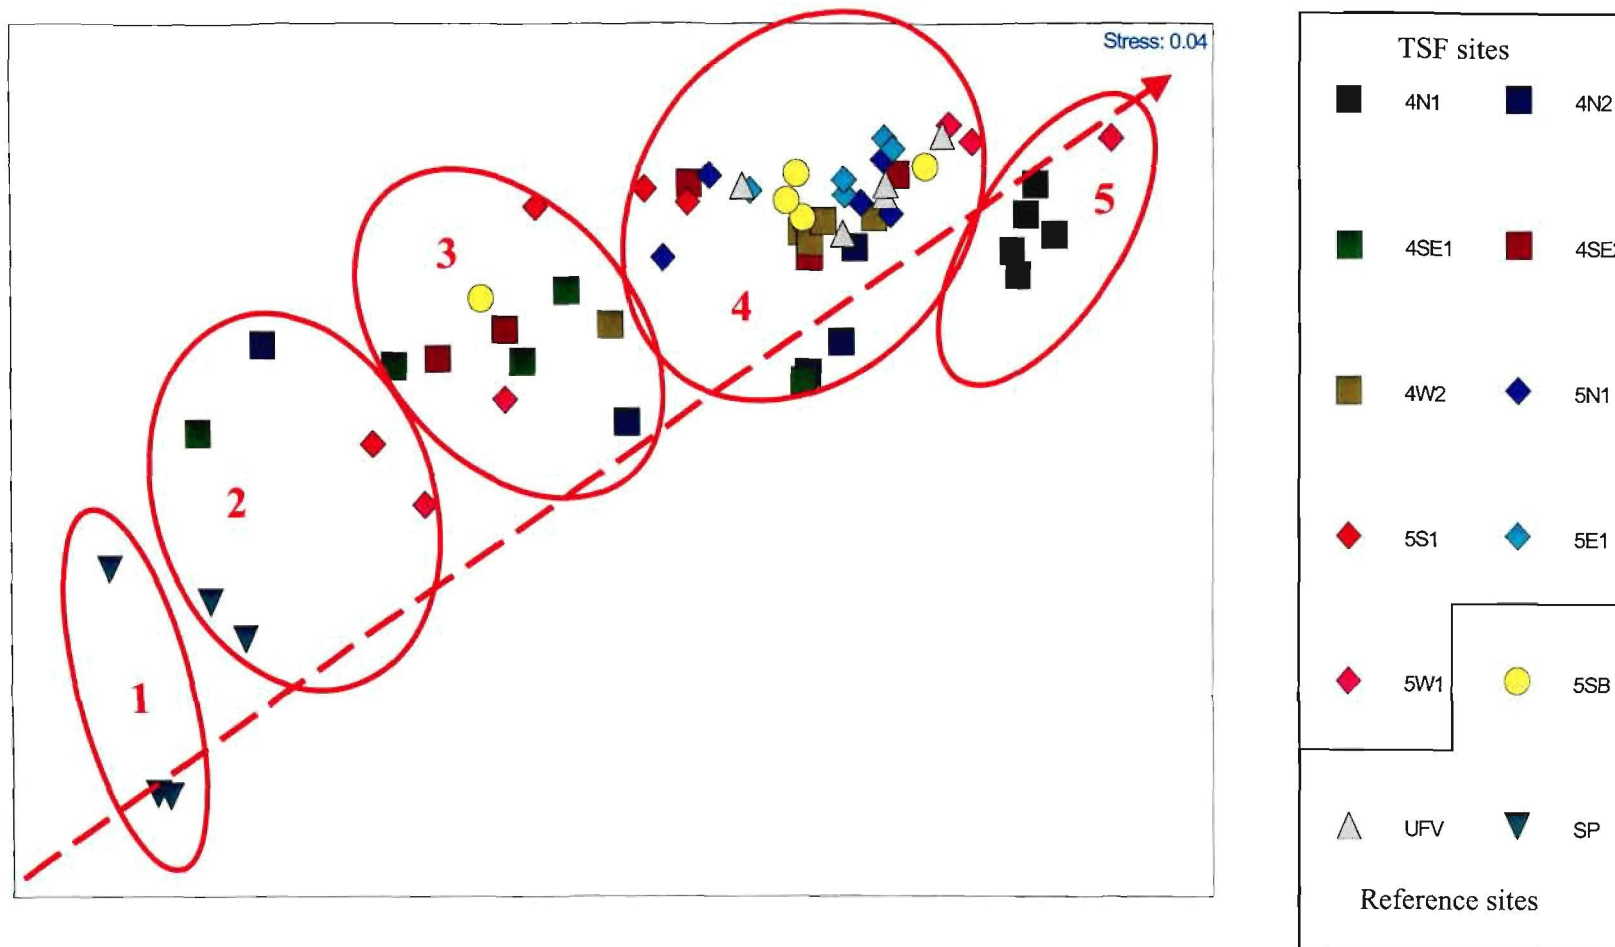
**Figure 5.9.** Non-Metric Multidimensional Scaling diagram of the 2007 LFA index -related site-associations. The red ovals indicate the site groupings and have numbers derived from Figure 5.8. The groupings are repeated in Figures 5.10 and 5.11 for 2008. Site names and abbreviations are explained in Appendix A.

Similarity was based on Bray-Curtis distance as a measure of relative similarity between sites. This allowed for the graphic illustration of similarities between sites making use of MDS (Figures 5.9 and 5.11), similar to the vegetation analyses. As in the vegetation analyses, consistent patterns emerged between the successive survey years. In Figures 5.9 and 5.11, a functionality gradient was evident, with the least functional sites grouping at the bottom left of the graphs (SP) and the most functional grouping at the top right (4N1). Most sites showed similar relative positions to one another in 2007 and 2008 except for the spillage site (SP), which increased in organisation over time but not in functionality. In 2008, most sites displayed improved landscape organisation, whilst functionality either improved or declined slightly.

Figures 5.8 and 5.10 did not present the data organised along a restoration gradient, as did Figures 5.9 and 5.11, but rather the spread of functionality scores for each individual sample. This was an indicator of the internal variation within sites based on the combined LFA indices. When not split into sampling units, it became evident that some transects could have grouped with transects from other sampling units and different aspects, even different tailings dams, based on the indicator scores that comprised their landscape function.

The relative similarities between Group 1 sites were further illustrated by their BCS values. Group 1 split from the other poorly functional transects at 82% BCS in 2007 (Figure 5.8) and at 85% in 2008 (Figure 5.10). However, these differences were largely compositional, as Figures 5.7, 5.9 and 5.11 showed that the functionality changed very little. The functionality gradients that were indicated by the dashed arrows in Figures 5.9 and 5.11 run from the bottom left to the top right of the diagrams, with all of the spillage (SP) sites being comprising the least functional transects in both years.
