Use of Satellite Images to map Flood Extension around the city of Saint Louis in the Senegal River Estuary

Aliou Dia, Jacob Loulou Kouame, Jean-Paul Rudant and Soulye Wade.

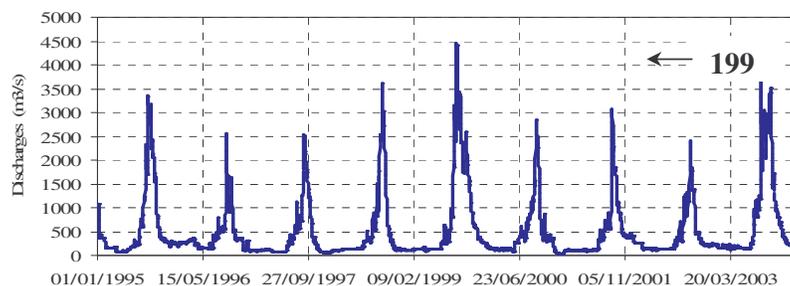
Figure 2: Time Series of Discharge at Bakel (1995-2004)

Due to exceptionally high rainfall in Fouta-Djalon in the rainy season of 1999, peak flow at Bakel was reached of $4440 \text{ m}^3/\text{s}$ (IRD¹, 2001).

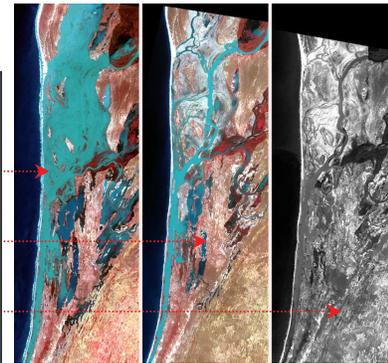
Figure 3: SPOT images

The SPOT 4 images (1999, 2001 and 2002) were acquired from a project developed by University of Dakar in collaboration with University of Marne la Vallée (France).

Date	Mode	Season	Observations
23 1999	XS 4	Rainy	high floods
31 2001	XS 4	Rainy	low floods
16 2002	Panchromatic	Dry	no floods

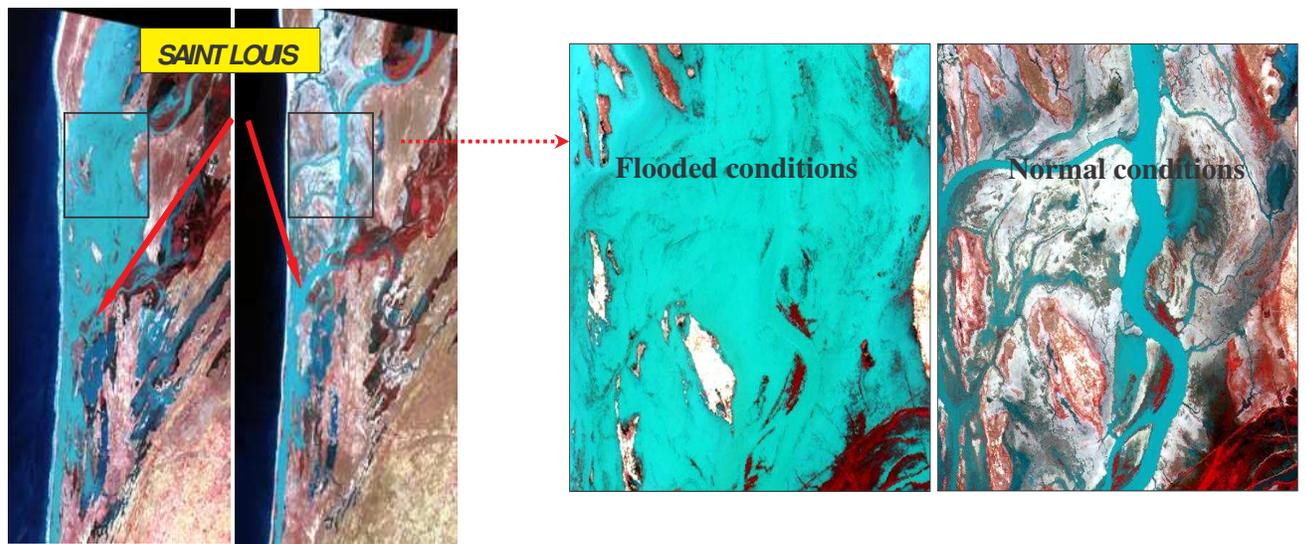
Figure 4: Satellite Imagery of Senegal River Lower Estuary, Flood conditions in October 1999 (left) and no flood conditions in October 2001 (right)

The satellite image below (figure 3) indicates the difference between the floods of 1999 and non-flood conditions. Unlike the normal floods, which cover large parts of the valley for several days or weeks during August to September 1999, the floods in 1999 lasted until mid-October in many areas, killing people and destroying roads, houses, crops, and other assets.

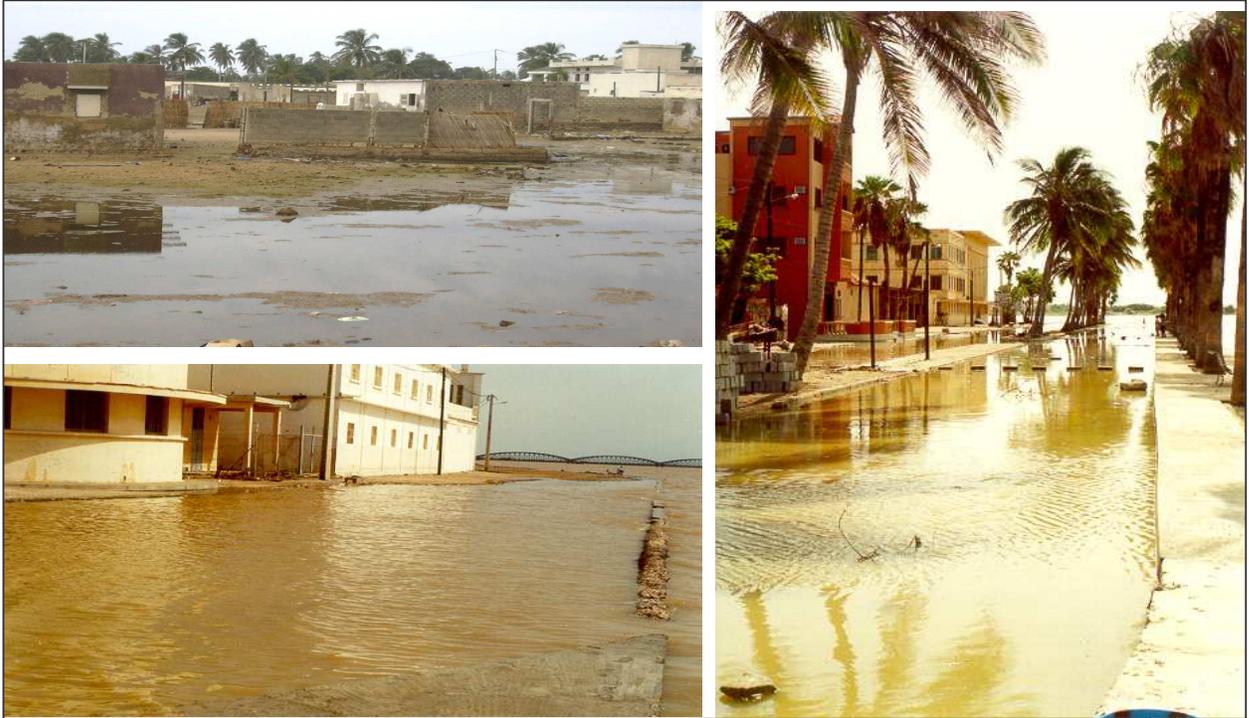
Figure 5: A view of flooded area in Saint-Louis in 1999

The impacts of the floods were severe because of the high levels of vulnerability and low levels of resilience of the population, the lack of adequate physical protection infrastructure and changing flood patterns due to environmental change as well as the impact of the Diama dam's structures. Man-made factors contributed to the seriousness of the event. The increasing occupation of floodplains around the city of Saint Louis in the estuary, competing and conflicting developmental demands in the lower Senegal river valley have exacerbated the impacts of floods on society (Dia, 2004). Even though the floods are obviously a fact of nature, their impacts on local resident depend on a large scale on the behaviour of the population.

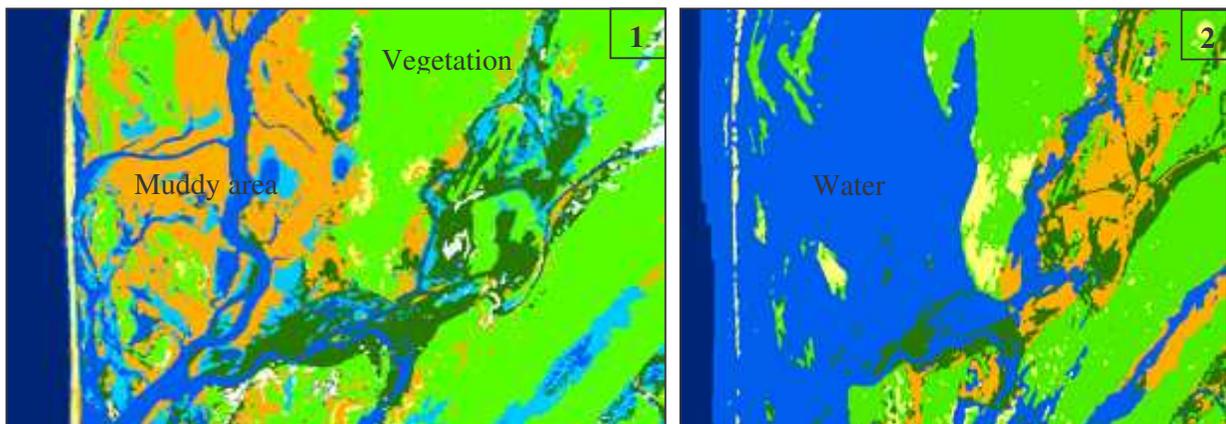
Figure 6: The classification results (1. Normal situation in 2001, 2. Flood situation in 1999)

A standard supervised maximum likelihood classification was carried out using the ENVI (environment for visualizing images) image processing system. A total of five spectrally different classes were identified corresponding to spectral variability in the image. Differences on water reflectance are caused by turbidity and water depth and presence of varying amounts of green vegetation. Training and test areas were defined using field observations and delimitation carried out from a visual interpretation of SPOT images.

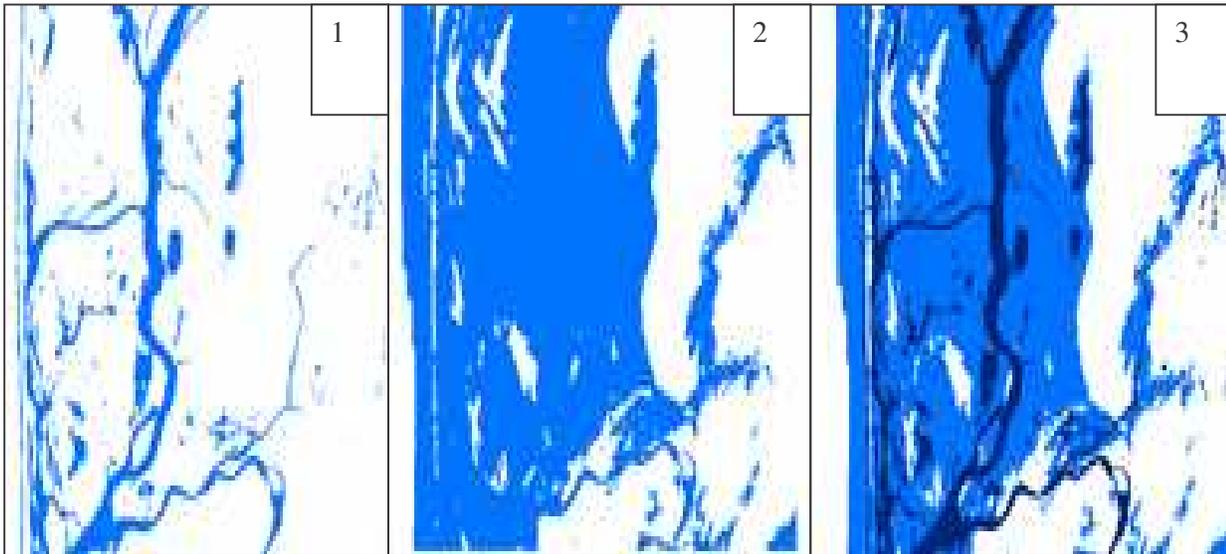
Figure 7: Flood extension in 1999

(1. Normal situation in 2001. 2. Flood situation in 1999, 3. Comparison of the 2 periods)

The cartography of flooded areas of the Senegal River estuary, permitted to isolate the different zones affected in October 1999. It is a multi-temporal approach which consists in comparing water surfaces around the city of Saint-Louis between the flooded period (SPOT 23/10/1999) and the normal period (SPOT 31/10/2001). The river bed largely overflowed and all the regions in the north of the town of Saint-Louis were considerably flooded.

The flood map referred to here (figure 7) is a map that graphically provides information on the extension of inundation in an easy-to-understand format. The goal is to show the high level of vulnerability of many areas around the city of Saint-Louis to practitioners active in disaster risk reduction and those in charge of rivers and hydrology at local and regional level. The flood hazard map is particularly handy for planners and administrators in formulating remedial strategies. It also makes the process of resource allocation simple, resulting in a smooth and effective implementation of the adopted flood management strategy.
